Building Survey

Valuation report

SAMPLE SURVEY

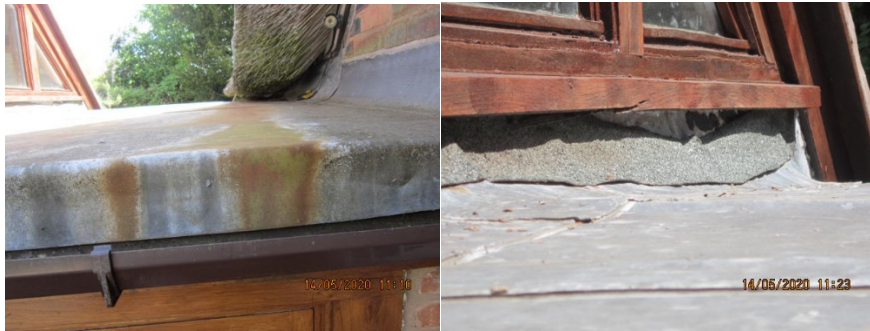
There is a flat lead roof covering to the section between the original building and the extension. The roof covering shows light rusting but no signs of water penetration was noted to the ceiling below. The roof covering is considered to be in serviceable order. There is a mineral felt flashing between the flat roof covering and the extension. A section of the flashing has dropped and requires re-fixing.

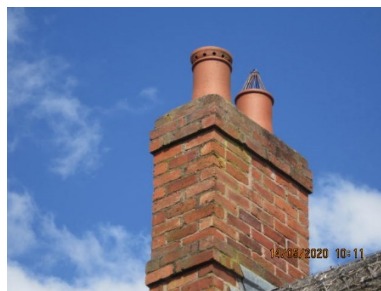
The left side chimney stack is constructed from brickwork with stepped lead flashing and two clay pots. The chimney stack shows signs of general weathering but was considered to be in serviceable order. One chimney pot is fitted with an open grill cage and one with a clay terminal.

Open chimney pots should be fitted with a terminal fitting that will prevent rainwater and nesting birds entering the chimney flue which may cause problems with dampness to inside walls or to the flue becoming obstructed. The chimney pot terminals should also be appropriate for solid fuel fires set in thatched roofs. These chimney pot terminals are not considered to be appropriate for thatched roofs and should be replaced with suitable fittings.

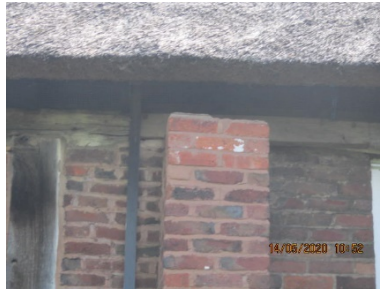
To the left side of the property there is a brick built chimney stack however this has been reduced below the eaves level and capped. The chimney flu is now redundant. The redundant flu should be ventilated at the top and bottom to guard against condensation occurring within the sealed flu.

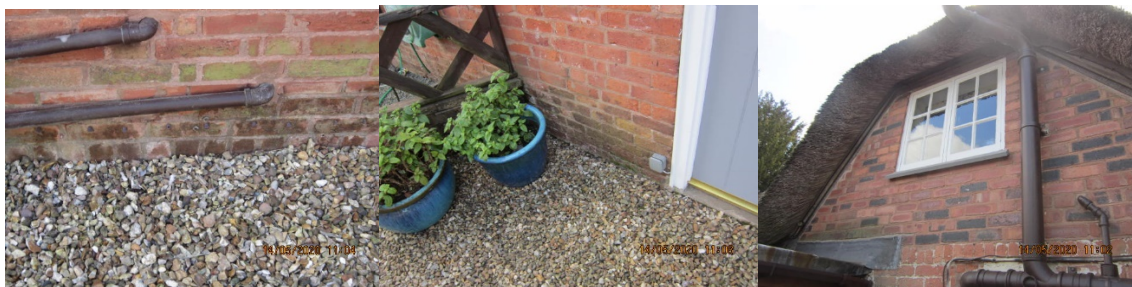
There is some evidence of damp staining at the base of the outer wall to the rear elevation and above the flat roof which suggests that the clearance is not adequate. The amount of clearance provided should be discussed with the thatched when the roof is next replaced.

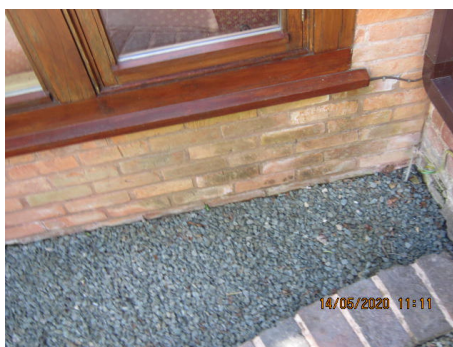
There is evidence of damp staining at the base of the outer walls which appeared to be dry at the time of inspection and may be the legacy of historic problems. Rainwater goods should be subject to routine maintenance to include clearing debris resealing joints and realignment as necessary.

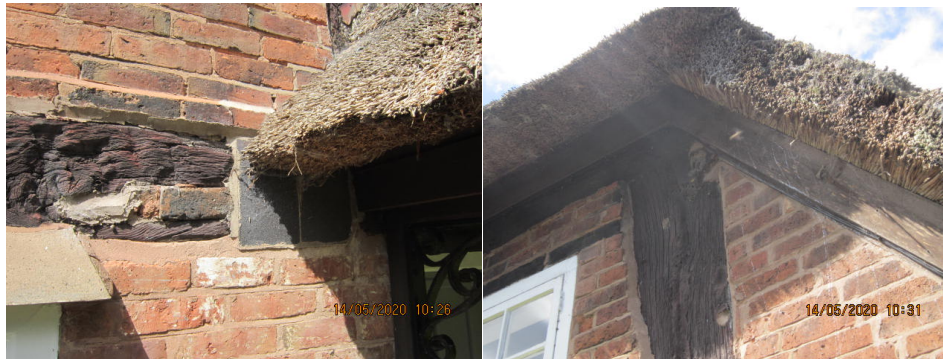
It is evident that this timber frame has been severely damaged with sections cut and removed, presumably because of rot to timbers. Where the timber frame has been cut/removed additional brickwork has been provided. A number of the timber joints lack pegs which have either rotted or been removed and this will mean that the joints are not secure. Elements of the timber frame are severely weathered and there are other areas that show patch repair, using a combination of sand/cement and lime mortar and sometimes by inserting new sections timber frame and also by use of timber cladding. The timber frame has twisted however this is common in construction of this type and is considered to be within tolerance limits. The pointing to the brick infill panels is largely in a sand and cement mortar however, we would expect that originally a lime-based mortar would have been used. Sand and cement mortar is not considered to be suitable for use within timber framed buildings as it is likely to cause further deterioration to the timber frame. You should make provision for repair to deteriorating timber joinery however it is not possible to assess the full degree of any deterioration to timber joinery without a destructive test. This should be discussed with the current owners.

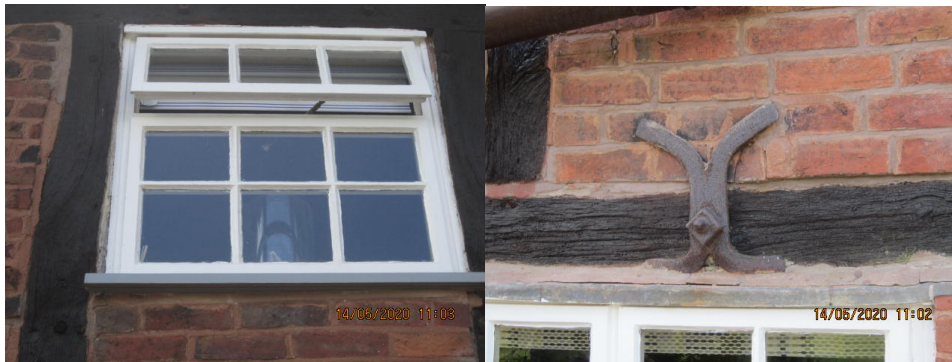
There is evidence of the use of metal tie beams to part of the property, these are considered to be historic in nature and are considered to be a characterful feature of the property.

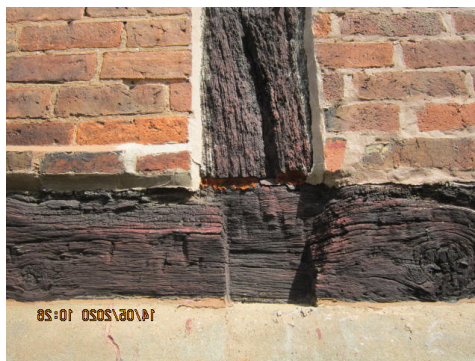
Evidence of the use of expanded foam filler was noted around some joints however this is not considered to be consistent with the listed status of the building.

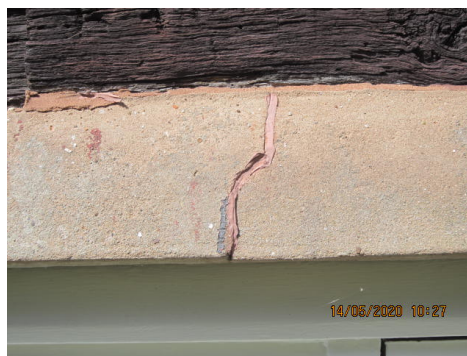
There is a concrete lintel spanning the ground floor window frame to the right side of the property. The lintel has cracked and has been filled with mastic sealant. The lintel requires replacement.

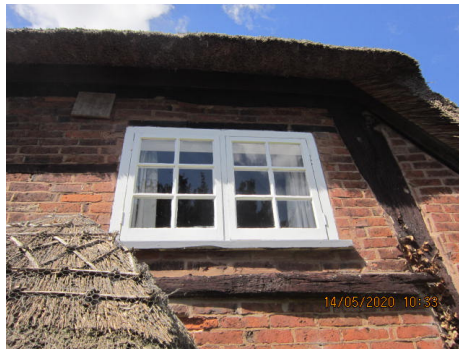
The timber lintel spanning the window frame first floor to the right side elevation is under sized and requires upgrading.

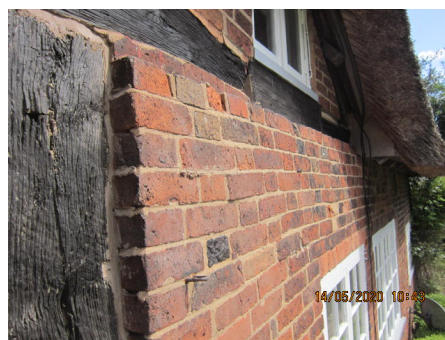
The brickwork to the infill panels within the timber frame is generally twisted and is out of square. This is particularly noticeable to the front and right side elevations however this was considered to be within tolerance limits and a common feature in walls of this type. The infill brickwork above the ground floor window frames to the front elevation is proud of the timber frame creating a water trap which may allow water penetration. Whilst no problem was noted at the time of inspection the joint should be sealed to help prevent any problem of water penetration.

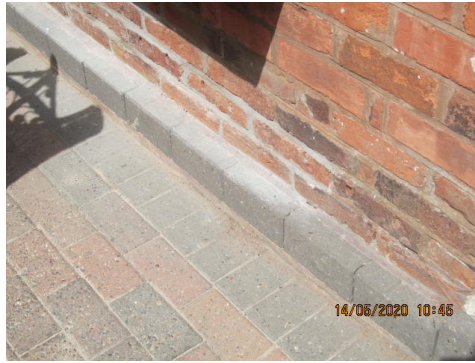
Brickwork to all elevations is generally pointed in a in a sand and cement mortar although there is some localised evidence of lime mortar. The original pointing in a property of this age is likely to have been lime mortar. Sand cement mortar is inappropriate and may be causing damage to the timber frame.

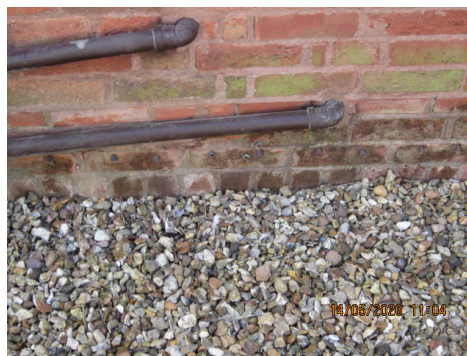
There is evidence in some areas of an injected damp proof course which will have been installed within recent years and may benefit from a contractor guarantee. There is evidence of dampness to the internal walls which indicates that the damp proof course is not working effectively. It should be noted that it will be difficult to install an affective damp proof course to random stonework due to the nature of its construction. A full damp inspection should be undertaken by a PCA approved specialist surveyor with recommendations to be acted upon in full.

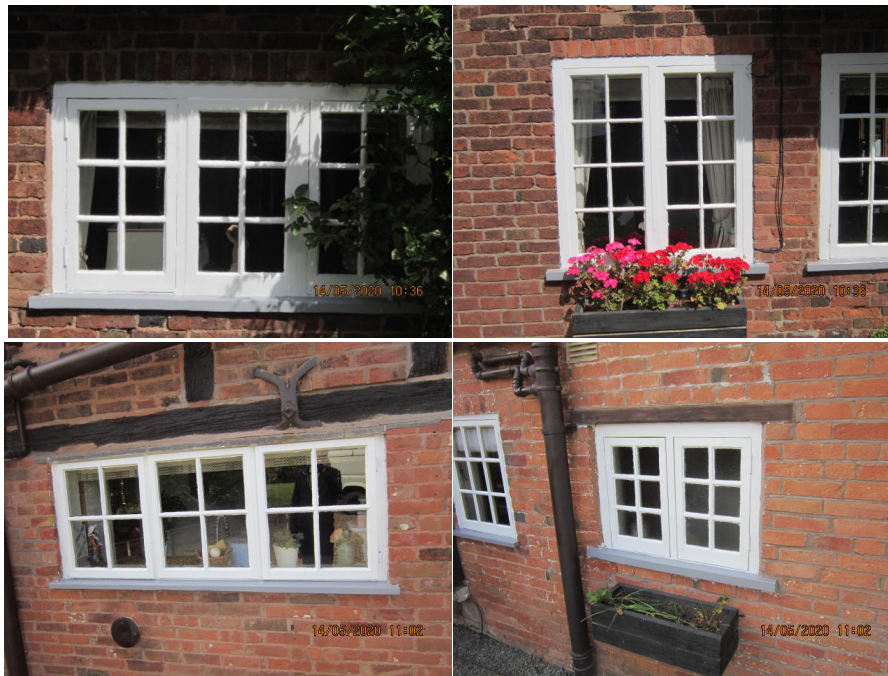
Window frames around the property are of softwood timber construction with single glazed casements. The window frames were regarded as being well decorated with the redecoration undertaken recently. It is understood that the window frames form part of the listed status and will have to be repaired and maintained in accordance with Listing requirements. There is evidence of past cut and fill repair. The amount and extent of this repair is concealed below painted finishes. You will need to make provision for ongoing maintenance to all window frames and for this to be carried out within planning guidelines.

A random sample of opening casements were tested and were found to be seized or swollen and difficult to close. Opening window casements will require easing.

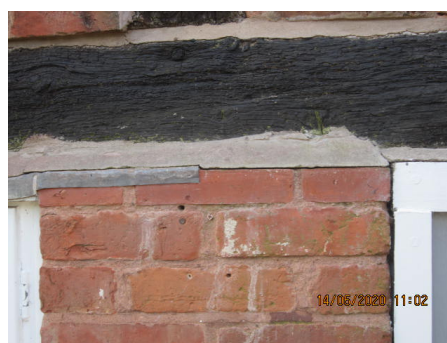
Window/door frames are not fully sealed which will mean they are not fully watertight and may be prone to water penetration. (the use of silicon based sealant is likely to be prohibited). The lead flashing above the Utility window frame may trap moisture against the timber and cause rot. The lead flashing should be removed, window frame re-sealed and defective joinery repaired as necessary.

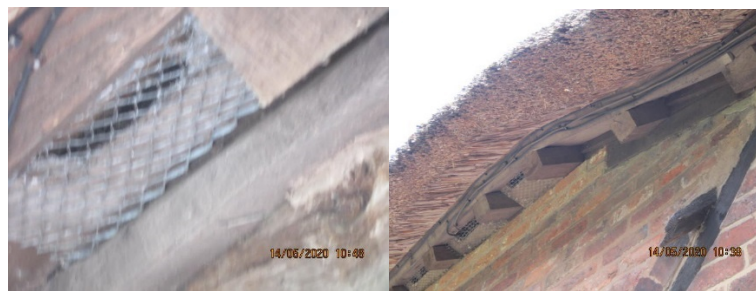
Timber soffit boards within the eaves are fitted with ventilation openings. The ventilation openings vary in size and are covered by a variety of metal mesh which varies in gauge. The larger gauged mesh may allow access by birds, bats or other vermin.

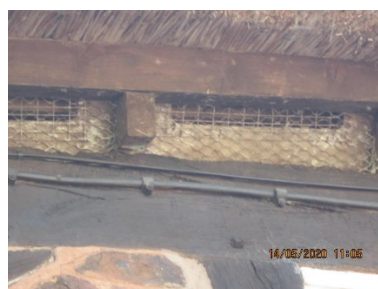
It was noted that the soffit boards to the rear elevation, above the door, are formed from a material that may contain asbestos. Comments made later in this report relating to asbestos containing materials should be noted.

Materials that may be found to contain asbestos were noted around the property (eaves boarding). Advice should be taken from a specialist asbestos surveyor to confirm how these substances should be managed or removed.

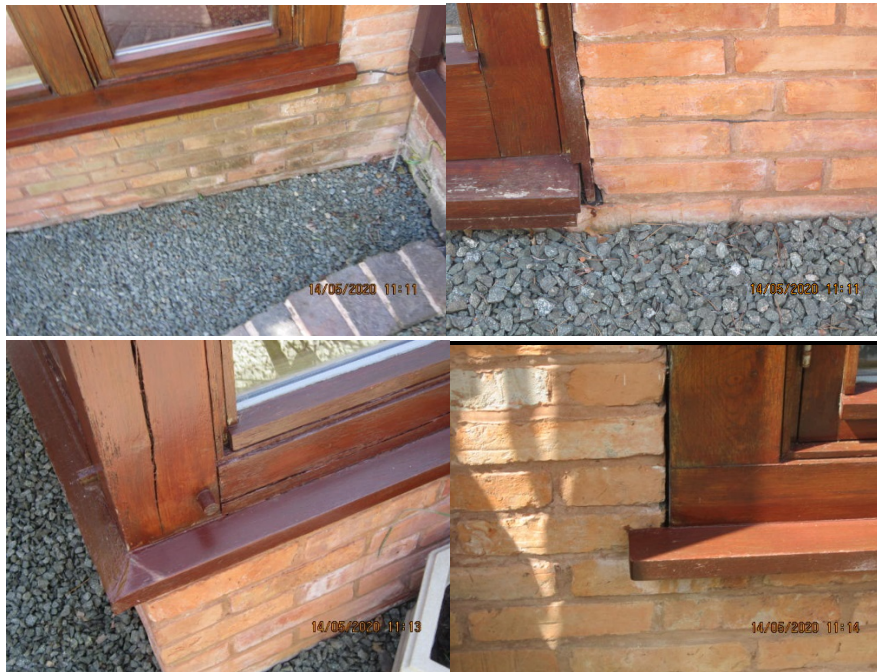
Timber window frames were regarded as being generally well decorated however there is some evidence of general weathering along with deterioration of joinery and past repair. Frames are not flush to adjacent brick walls and are not fully sealed. Mastic seals have split and require re-sealing.

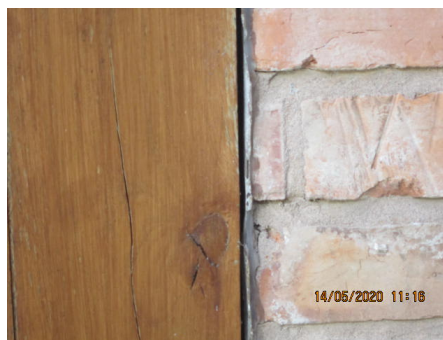
The seal at the base of the door frame is missing and should be finished. Evidence of dampness was noted at the base of the outer wall however this appeared dry at the time of inspection was considered to be historic in nature. Window frames to the left and right side elevations protrude beyond the line of the face of the brickwork and are not fully sealed.

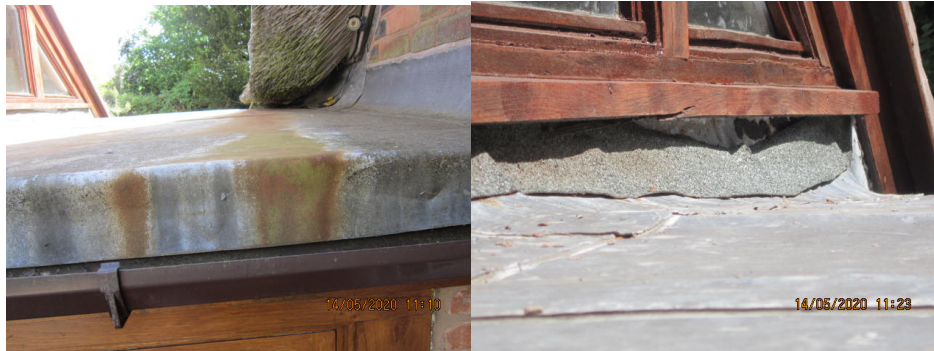
The flat lead roof covering shows general weathering but no signs of water penetration was noted to the ceilings below and was considered to be in serviceable order. The felt flashing to the gable has slipped and requires re-fixing. All flat roof coverings have a limited lifespan and will require repair/maintenance from time to time.

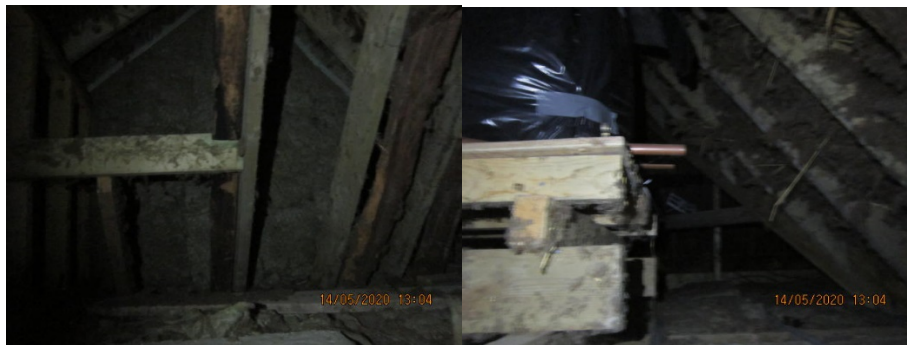
The roof structure is of timber Purlin and Rafter construction, there is no felt below the outer layer of thatch. Many original roofing timbers have been replaced due to fire damage although some fire damaged timbers remain for historical reasons. The roof covering was re-thatched circa 1995. Whilst no obvious signs of water penetration was noted at the time of inspection we recommend that it is inspected by a specialist thatcher to confirm its serviceability, need for maintenance and expected life span.

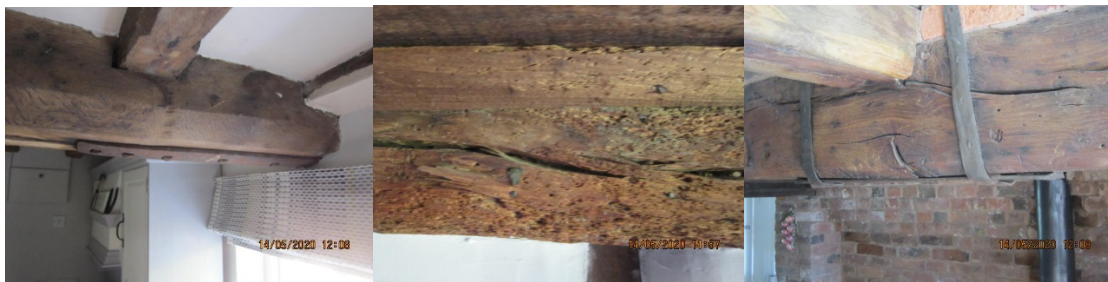
A feature of the property are the original timber beams and joists, these show signs of distortion, past cut and repair, strengthening as well as evidence of timber infestation. These beams are an important feature of the property and would form part of the listed status. Given the nature and age of construction the beams appeared to be performing adequately at the time of inspection.

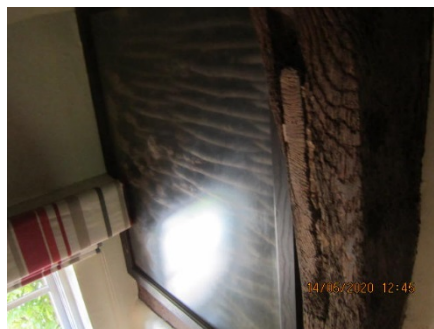
There is evidence of the original wattle and daub in a display panel located in the central stairwell. The extent of wattle and daub to walls and ceilings cannot be confirmed and its maintenance will be a requirement of the listed status. It should be noted that original wattle and daub contains organic matter which will be considered to be a biological hazard and a possible source of anthrax. You are advised to seek professional advice on this matter.

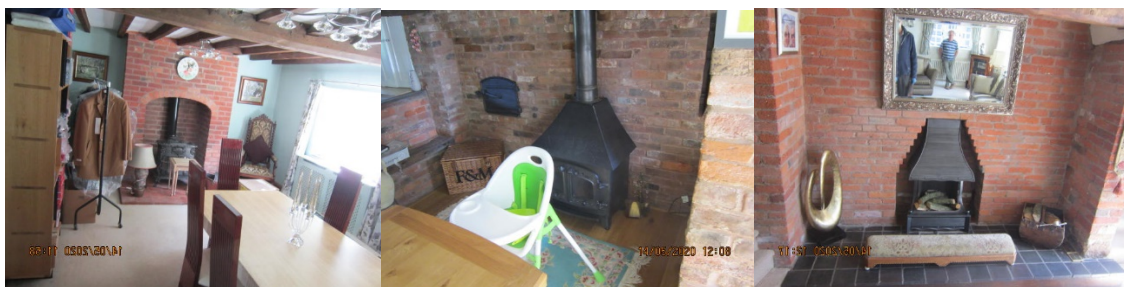
The chimney breast in the front left reception room is installed against an outside wall and is fitted with a solid fuel burner. There is a central chimney stack which provides fireplaces to the centre and front right reception rooms. There is no evidence of external ventilation to any rooms containing the solid fuel fires. It is not possible to inspect the chimney flu and we are unable to comment upon their condition nor can we confirm that the class of flu is appropriate to the appliance. The flue and the associated heating appliance should be serviced annually and prior to first use. Solid fuel fires of this type are not considered to be suitable for use in buildings with thatched roof as they are considered to be a fire hazard. There is some evidence of fire retardant cladding to the chimney breast within the roof void but we are unable to confirm that the extent of fire protection is adequate and in line with current recommendations.

Current guidance suggests that solid fuel fires, and wood burners in particular, are not suitable for properties with thatched roofs. Current owners advise that the solid fuel fires are not in use. It will be necessary to advise insurers of the existence of solid fuel fires and wood burners in particular so that buildings insurance can be assessed and full and appropriate insurance cover provided.

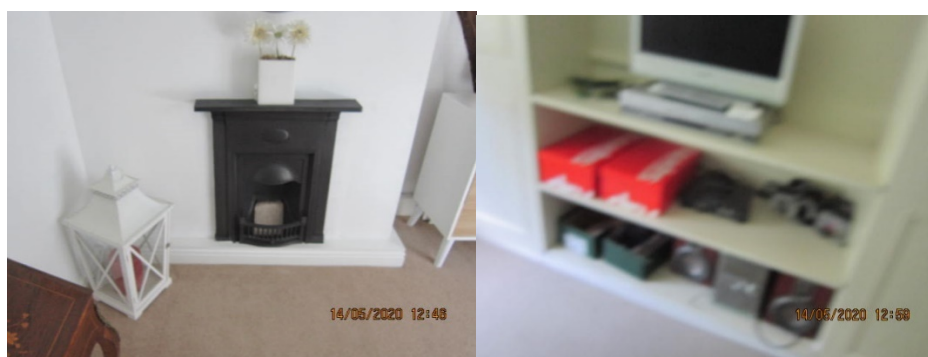
The fireplaces in the first floor bedrooms have been sealed. When a fireplace has been taken out of a chimney breast and the opening blocked up the top of the flu at chimney level should be fitted with a terminal fitting that keeps out the rain but allows ventilation of residual moisture in the flu and the sealed flue should be fitted with ventilating airbricks to the outside air towards the bottom of the flu to help reduce the risk of condensation in the sealed flu.

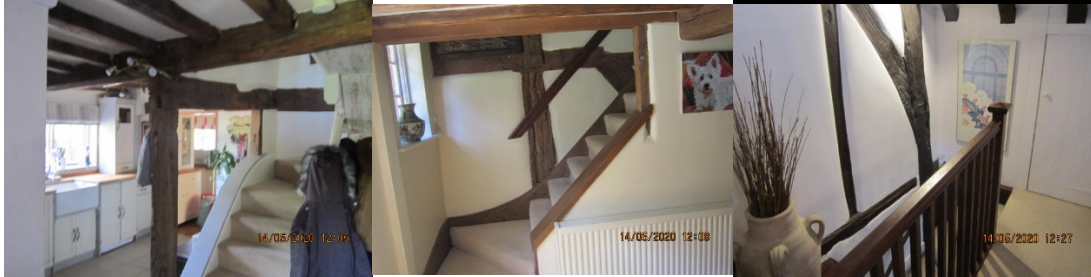
Whilst the staircases were found to be twisted and uneven they were generally firm underfoot and considered to be in functional order. There is no outer handrail to the lower section of the staircases leading from the utility room and kitchen, this does not comply with current regulations and is considered to be hazardous.

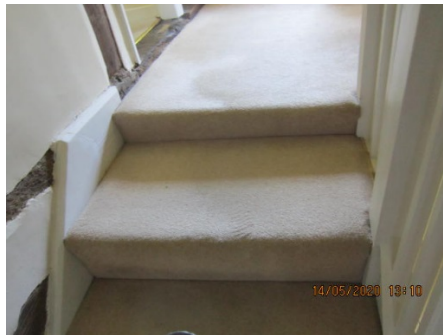
The short rise to the top step to the reception room staircase is a trip hazard and does not conform to current regulations.

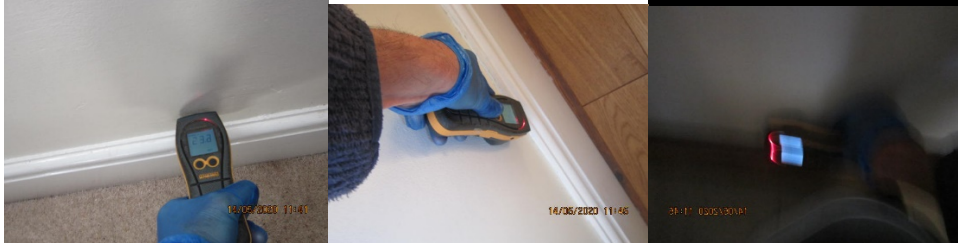
Moisture meter readings were taken throughout and evidence of high moisture content was noted particularly around the outer utility room and the main front reception rooms.

A full timber and damp survey should be undertaken by a PCA (Property Care Association) surveyor with recommendations to be acted upon in full.

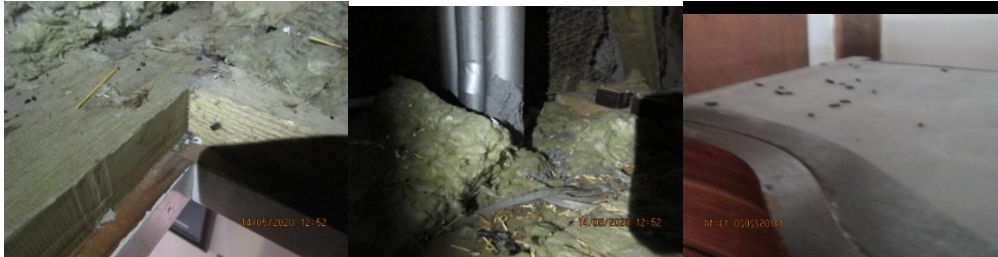
Evidence of vermin infestation in the form of droppings and damage to insulation was noted within the roof void and within some habitable rooms. Pest control specialists should be asked to advise on method or eradication.

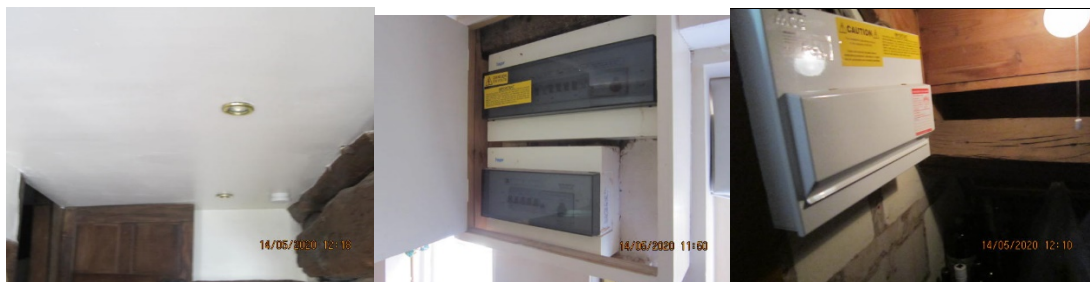
Some adaptations appear to have been made that will have required certification by an Electrician (e.g., replacement consumer units, spot lighting, extension wiring). The systems appear to be past their periodic inspection date (circa May 2018) The Institute of Electronics and Technology (IET) recommends that electrical systems are inspected and tested every ten years and upon every change of occupancy. You should ask an appropriately qualified person to inspect the electrical system now.

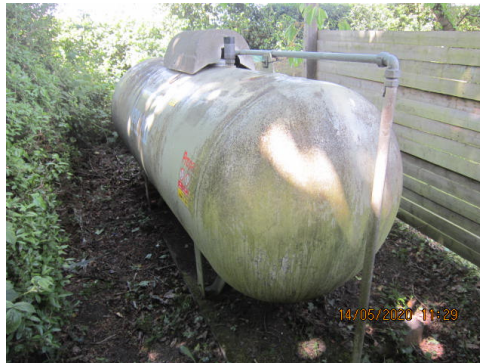
The property is served by and LPG system with gas storage tank located within the garden. We have seen no service history for the LPG tank and recommend that it is serviced in accordance with installers guidelines.

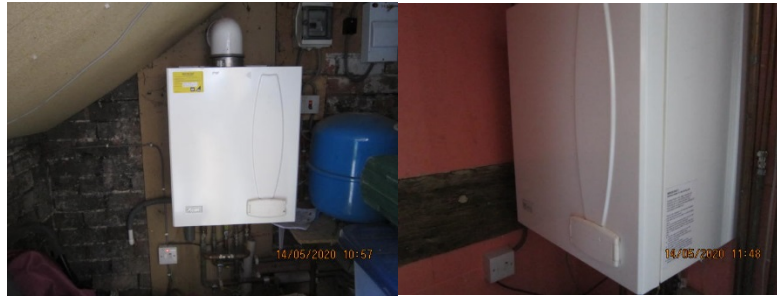
We have not seen evidence of the boilers service history. Heating installations should be serviced regularly (e.g., usually every year) by an appropriately qualified person who is registered under the government-approved competent person scheme. The competent person will leave appropriate documentation with the homeowner that identifies the type and extent of the work done. This should include all heating systems and appliances, for example, boilers, individual room heaters, all open fires, etc. The Surveyor has not seen evidence of the service history, these records should be obtained by Legal Advisors. Heating systems and appliances that have not been checked may be a safety hazard and should be fully serviced by a Gas Safe Engineer. The gas fired central heating system uses micro bore pipe work and this can be prone to inefficiency and furring.

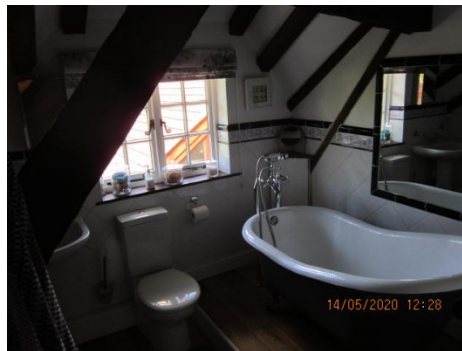
The fittings and appliances in the main en-suite bathroom are of modern design, show some wear and tear but were found to be in serviceable order. The column bath tap requires re-anchoring and cold tap requires easing. The bathroom would benefit from an extractor unit.

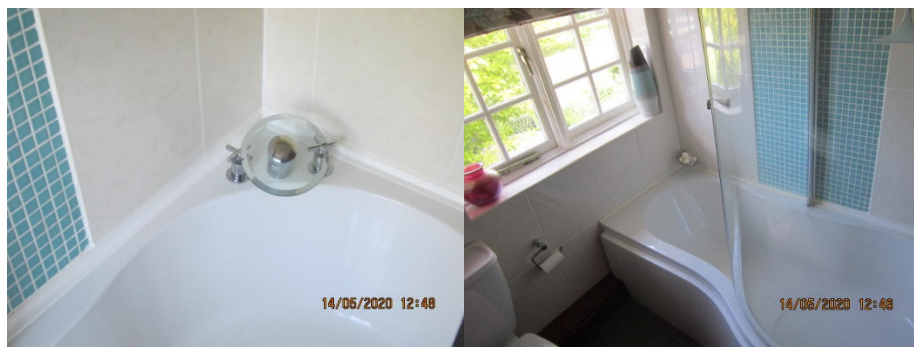
The fittings and appliances in the central guest bathroom of of mixed age but were found to be in serviceable order. There is evidence of the use of flexi-trim to the seal around the shower/bath cubicle. There may be some hidden defects to the timbers below. Defective seals should be made good and you should anticipate that some repair may be necessary to these areas when fittings are removed.

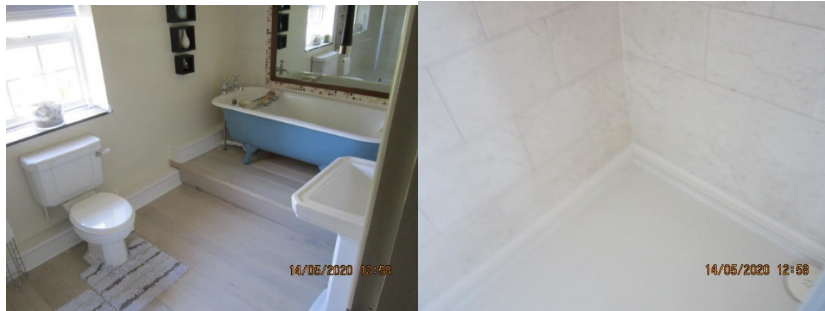
The fittings and appliances in the left side guest bathroom are of mixed age but were found to be in serviceable order. There is evidence of the use of flexi-trim to the seal around the shower cubicle. There may be some hidden defects to the timbers below. Defective seals should be made good and you should anticipate that some repair may be necessary to these areas when fittings are removed.

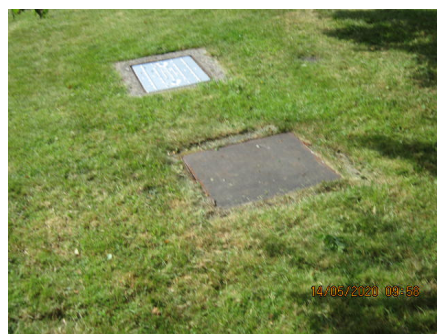
The property is served by a private, septic tank drainage system, we are advised that the system has been recently serviced but we have not seen any evidence of the systems service history. Legal advisers should be asked to obtain evidence of the systems service history.

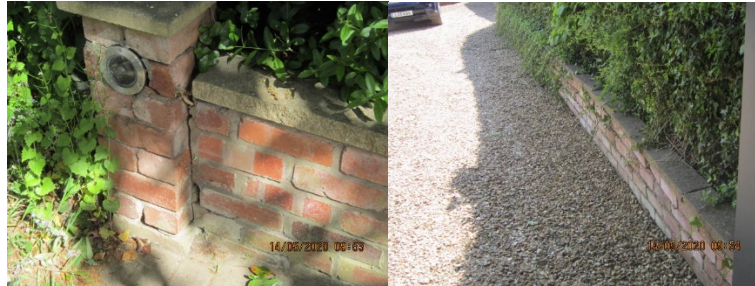
The garden walls adjacent to the rear drive to hardstand shows sign of impact damage and requires repair. Garden walls within the site are generally built from single leaf brickwork. We are unable to confirm that the retaining walls around the site are constructed to an appropriate specification although they appear to be adequately fulfilling their function at the time of our inspection.

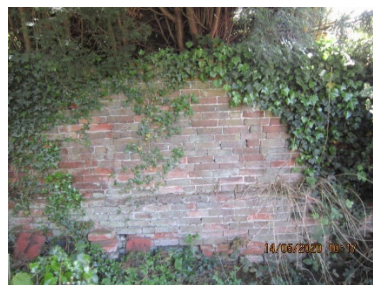
The party boundary wall to the right of the site is formed from solid brickwork. The wall is in poor condition, shows severe weathering and structural damage due to the proximity of trees. The wall requires extensive maintenance and the trees will need to be removed to prevent further damage.

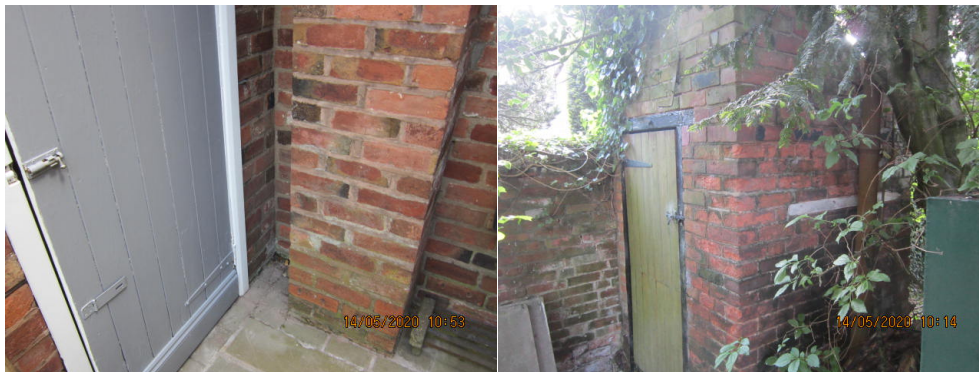
The brick built boiler store shows general wear and tear but was considered to be in serviceable order. The roof covering requires overhaul to include, repairing defective tiles and fitting rainwater goods. Defective joinery requires repair.

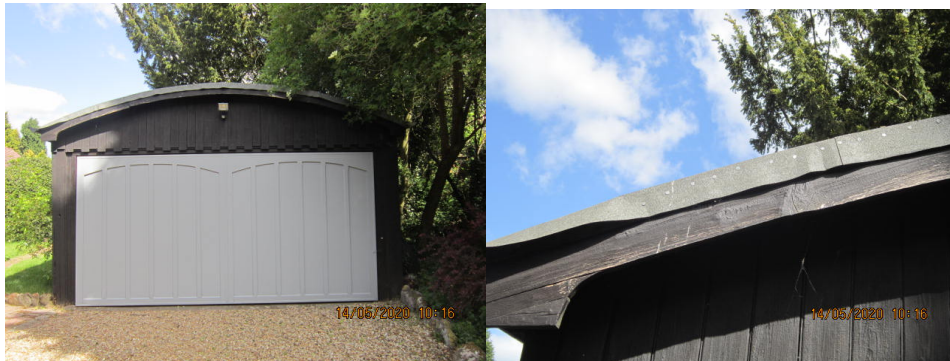
There is a detached double garage being of timber frame construction with curved felted roof and timber up and over door. The timber frame shows general deterioration and requires routine maintenance. The felt roof is loose fixed and requires refixing/overhaul. Eaves gutters are congested and require overhaul.
