LEVEL 2

Your survey and valuation report

B73 5TD, 2 Boldmere Road, Sutton Coldfield,
West Midlands, United Kingdom

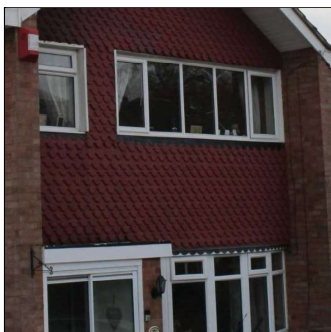
D5 Windows

Windows are plastic frames with sealed unit double-glazing. Windows show signs of general weathering but were considered to be in serviceable order. You should ask your Legal Advisor to confirm whether the windows have been installed by a FENSA registered Contractor and that guarantees are available for this work. Double glazed units can be prone to failure without notice and so provision should be made for on-going repair to these units. Condition rating 1.
