Building Survey

Valuation report

SAMPLE SURVEY

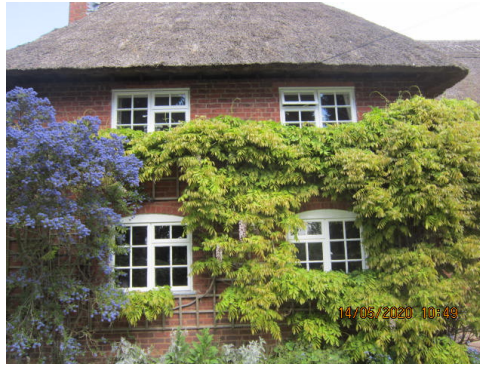
Part of the outer walls to the side and rear elevations were obstructed by the proximity of climbing shrubs. Concealed pipework within boxing and between floors could not be inspected. Belongings within various store cupboards restricted our inspection. Inspection of the roof void was undertaken from two loft hatches located at either end of the first floor accommodation. Roof timbers are hidden below insulation materials and access was restricted to observations made from the vicinity of the loft hatch only. Fitted wardrobes within bedrooms restricted our inspection. Defects may exist to unseen areas that we cannot readily comment upon.

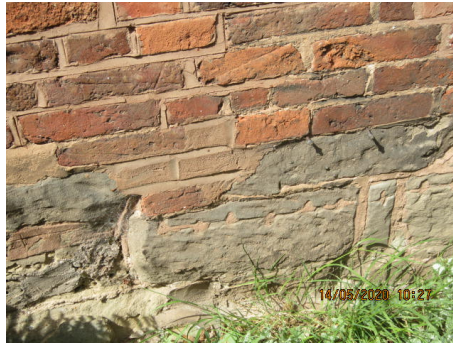
It is likely that the property is built on an alluvial sub-soil which is common in this locality.

From our inspection above ground we found no evidence of foundation failure. It is evident that the property has been subject to a large amount of structural movement but that is common in properties of this type and age. Period timber frame buildings of this type are designed to accommodate some movement of the timber frame which is a natural characteristic of the timber structure. It is evident that movement of the timber frame has caused further movement of the infill brick panels and that this movement is considered to be long-standing, non-progressive and within tolerance limits. This is a common characteristic of this type of construction.

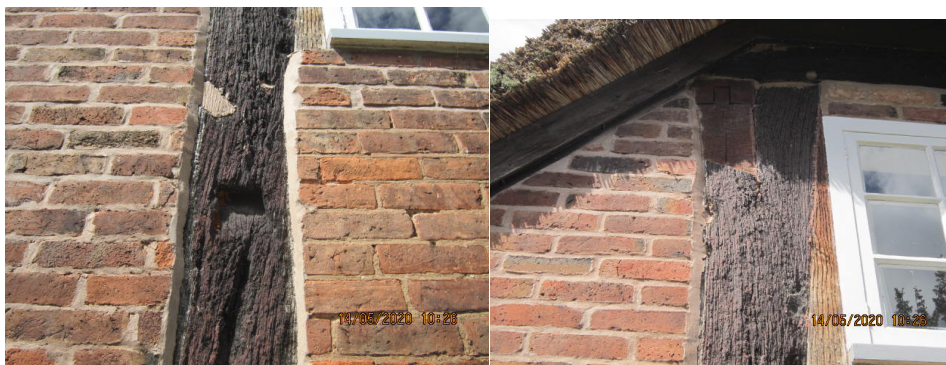
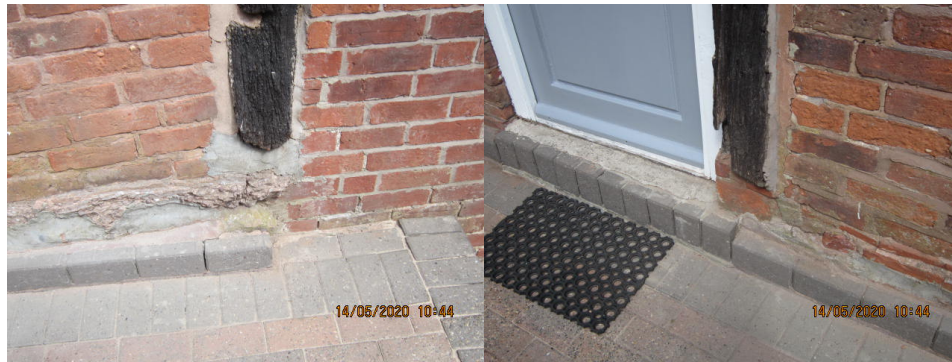
It is evident that this timber frame has been severely damaged with sections cut and removed, presumably because of rot to timbers. Where the timber frame has been cut/removed additional brickwork has been provided. A number of the timber joints lack pegs which have either rotted or been removed and this will mean that the joints are not secure. Elements of the timber frame are severely weathered and there are other areas that show patch repair, using a combination of sand/cement and lime mortar and sometimes by inserting new sections timber frame and also by use of timber cladding. The timber frame has twisted however this is common in construction of this type and is considered to be within tolerance limits. The pointing to the brick infill panels is largely in a sand and cement mortar however, we would expect that originally a lime-based mortar would have been used. Sand and cement mortar is not considered to be suitable for use within timber framed buildings as it is likely to cause further deterioration to the timber frame. You should make provision for repair to deteriorating timber joinery however it is not possible to assess the full degree of any deterioration to timber joinery without a destructive test. This should be discussed with the current owners.

There is evidence of the use of metal tie beams to part of the property, these are considered to be historic in nature and are considered to be a characterful feature of the property.

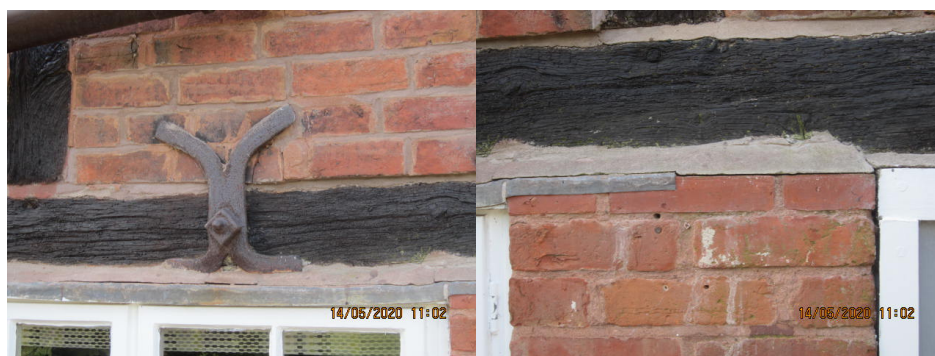
The brickwork to the infill panels within the timber frame is generally twisted and is out of square. This is particularly noticeable to the front and right side elevations however this was considered to be within tolerance limits and a common feature in walls of this type. The infill brickwork above the ground floor window frames to the front elevation is proud of the timber frame creating a water trap which may allow water penetration. Whilst no problem was noted at the time of inspection the joint should be sealed to help prevent any problem of water penetration.

Brickwork to all elevations is generally pointed in a in a sand and cement mortar although there is some localised evidence of lime mortar. The original pointing in a property of this age is likely to have been lime mortar. Sand cement mortar is inappropriate and may be causing damage to the timber frame.

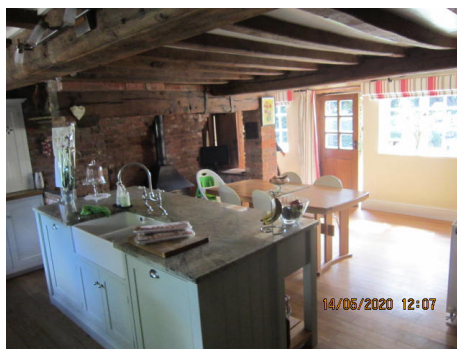
Kitchen and Utility units are of modern design. There is some evidence of general wear and tear but they were considered to be in serviceable order.

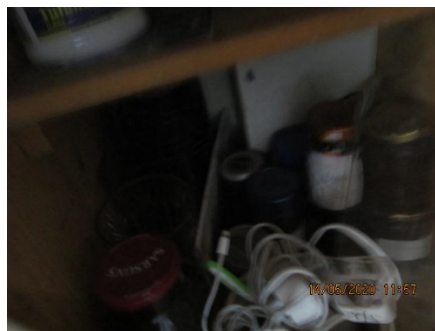
We are advised that the property is served by three mains cold water systems with a separate stop taps for each system being located in the kitchen below work tops and ground floor WC. Stop taps could not be viewed due to boxing.

We cannot confirm that the water supply pipe is not lead. Before 1970, many water supply pipes were made of lead and research has shown that small quantities can pass into the water. In some cases, lead can accumulate in the body and become a health hazard. This can be a particular problem in areas that have soft water. For further advice, visit the Drinking Water Inspectorate at www.dwi.gov.uk.

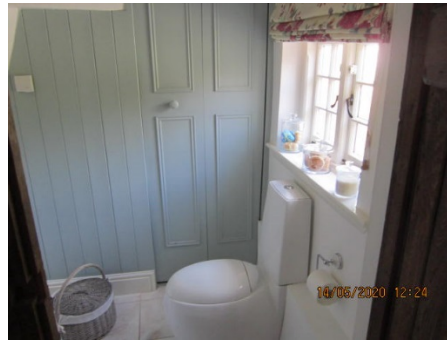
Ground floor WC fittings are of a modern design show wear and tear but were found to be in functional order.

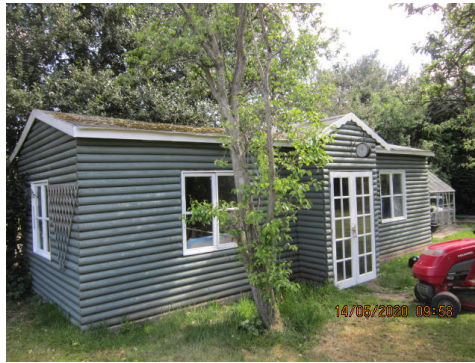
The timber storage shed is considered to be a temporary structure and is excluded from this report.

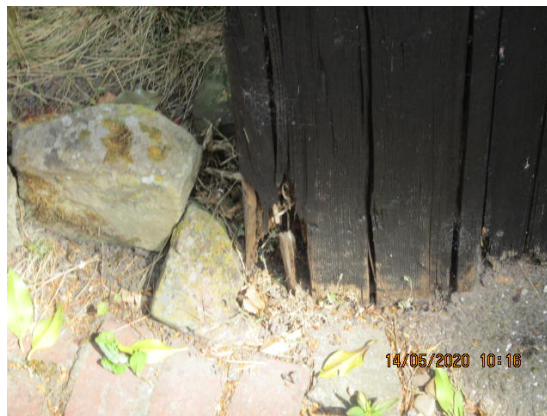
There is a detached double garage being of timber frame construction with curved felted roof and timber up and over door. The timber frame shows general deterioration and requires routine maintenance. The felt roof is loose fixed and requires refixing/overhaul. Eaves gutters are congested and require overhaul.
